Preliminary Dam Breach Inundation Analysis for the Copperwood Project

Administrative Report 24-01

**GREAT LAKES INDIAN FISH
& WILDLIFE COMMISSION**

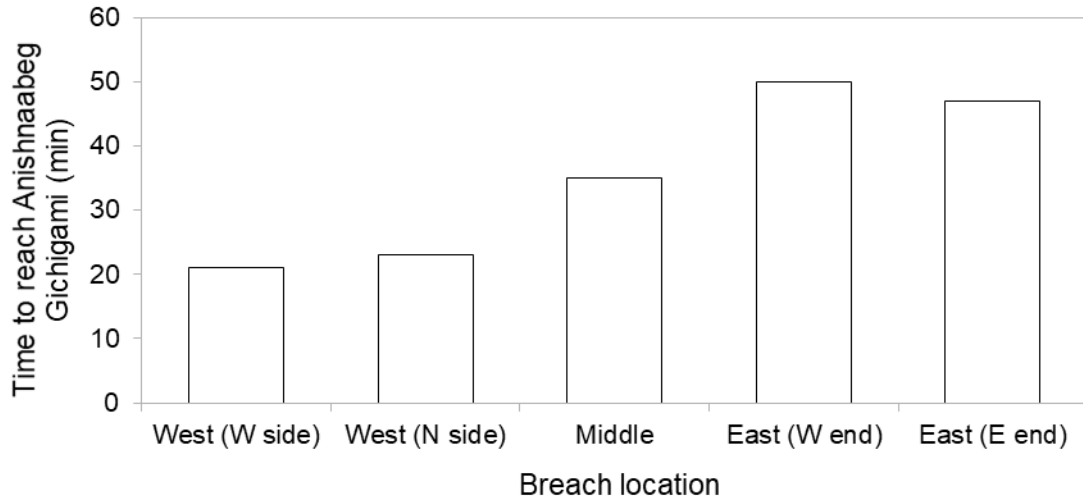
Fig. 6. Tailings flood arrival time to Anishnaabeg Gichigami for five breach locations assessed. Results represent time since beginning of breach formation.

In all principal dam breach models, tailings reached Anishnaabeg Gichigami (Lake Superior) in less than 1 hr after dam failure began (from beginning of breach; Figs. 1-6). Tailings from the western breaches reached the Lake the quickest (in 21-23 min; Fig. 6). Volume of tailings that had entered Anishnaabeg Gichigami 5 hrs after the breach ranged from 4.6 Mm³ to 8.6 Mm³ and was greatest for the western breaches (Fig. 7).

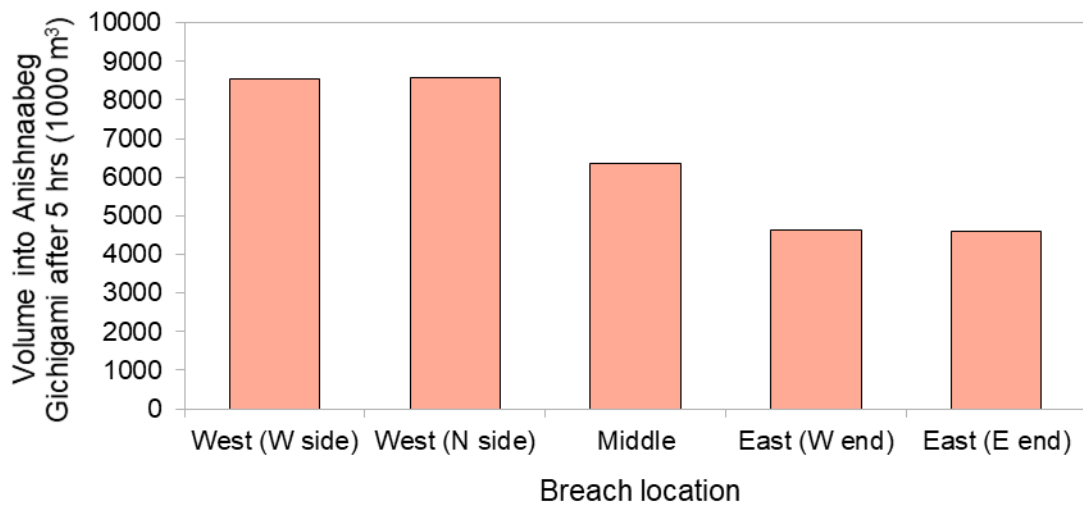
Fig. 7. Volume of tailings entering Anishnaabeg Gichigami 5 hrs after dam breach for five breach locations assessed.

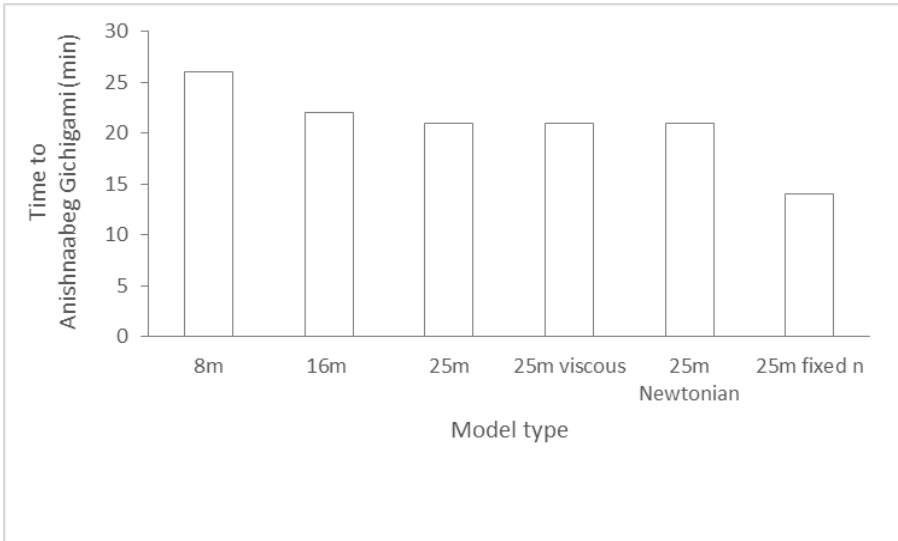
Fig. A1. Variation in time of arrival of tailings to Anishnaabeg Gichigami for a breach of the western side of the western tailings basin cell. Modeling used breach, rheological, and landscape roughness characteristics from Tables A1-3 unless indicated otherwise (model names include breach depth; viscous = maximum values from Table A1; Newtonian = Newtonian not Bingham fluid; fixed n = constant roughness of 0.03). Results represent time since beginning of breach formation.

Results for models with variations in parameters mostly did not differ greatly from results of the primary models (Appendix 1). More viscous tailings yielded results that were similar to the primary models except that more tailings remained on the landscape after 5hrs (Appendix 1). The most influential parameters were breach size and terrain roughness. Tailings in models with relatively shallow breaches took longer to reach the Lake, and resulted in lower volumes, depths, and surface area of tailings released (Appendix 1). The tailings in the main models with variable roughness reached Anishnaabeg Gichigami slower than a model with a fixed Manning's *n* of 0.06 (Appendix 1).

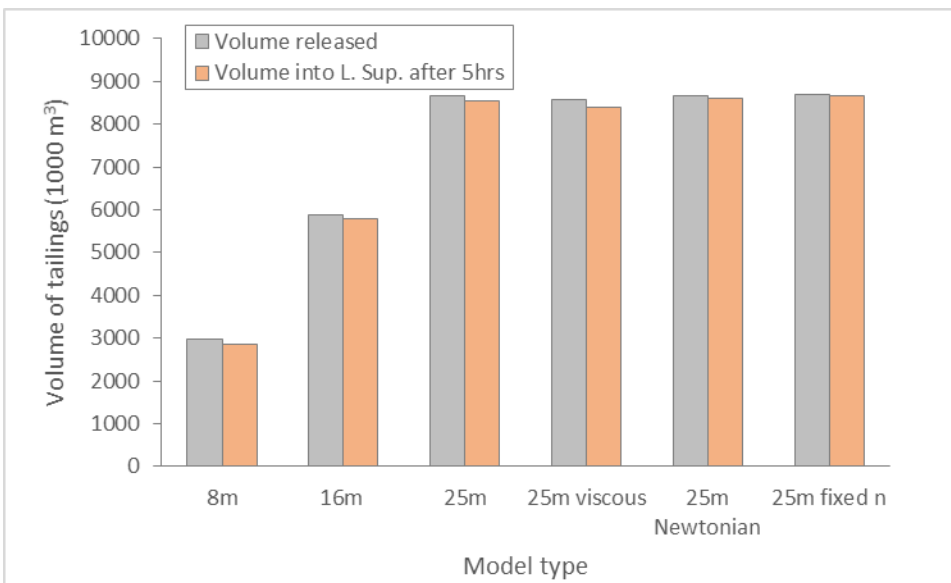
Fig. A2. Variation in volume released from breach and volume entering Anishnaabeg Gichigami after 5 hrs for a breach of the western side of the western tailings basin cell. Modeling used breach, rheological, and landscape roughness characteristics from Tables A1-3 unless indicated otherwise (model names include breach depth; viscous = maximum values from Table A1; Newtonian = Newtonian not Bingham fluid; fixed n = constant roughness of 0.03).

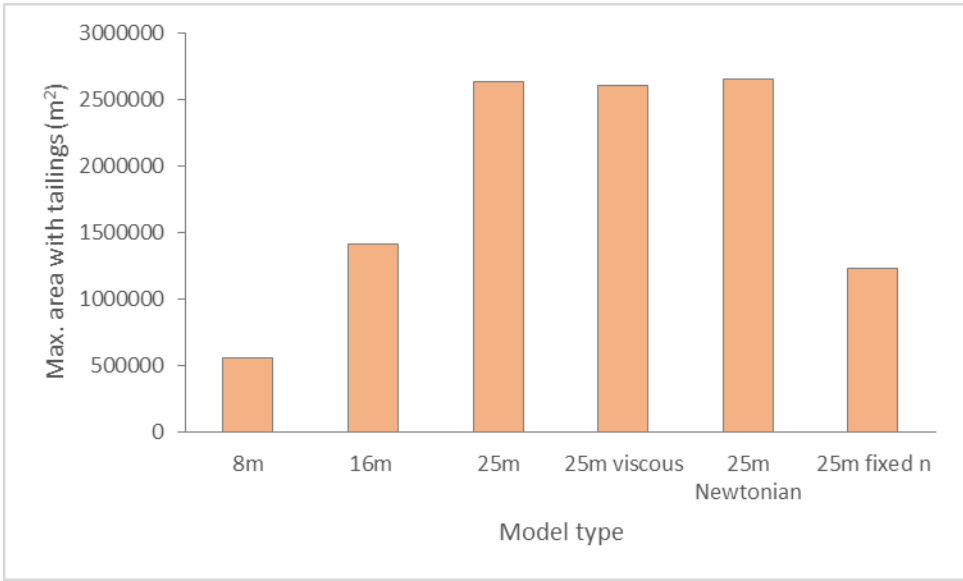
Fig. A3. Variation in maximum surface area with tailings for a breach of the western side of the western tailings basin cell. Modeling used breach, rheological, and landscape roughness characteristics from Tables A1-3 unless indicated otherwise (model names include breach depth; viscous = maximum values from Table A1; Newtonian = Newtonian not Bingham fluid; fixed n = constant roughness of 0.03).

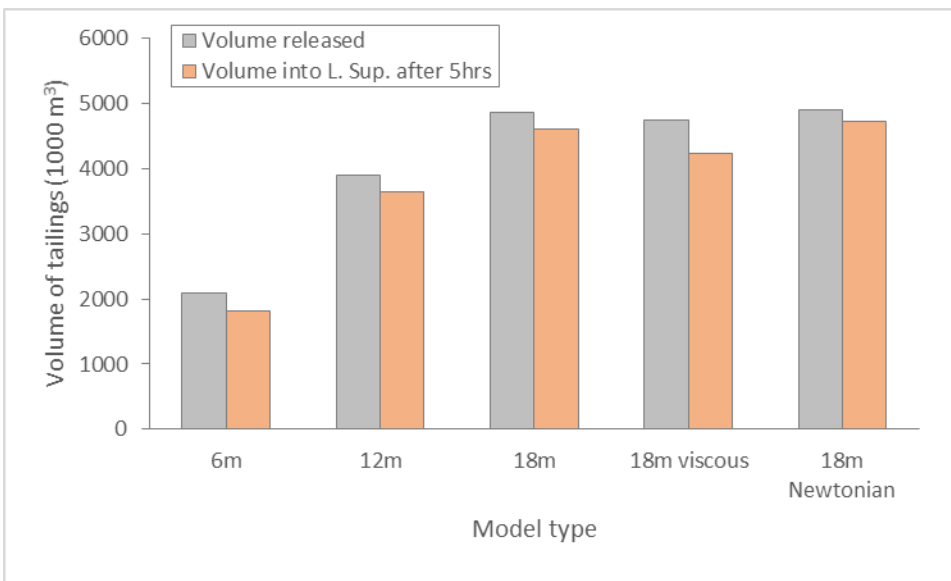
Fig. A6. Variation in volume released from breach and volume entering Anishnaabeg Gichigami after 5 hrs for a breach of the eastern end of the north side of the eastern tailings basin cell. Modeling used breach, rheological, and landscape roughness characteristics from Tables A1-3 unless indicated otherwise (model names include breach depth; viscous = maximum values from Table A1; Newtonian = Newtonian not Bingham fluid).

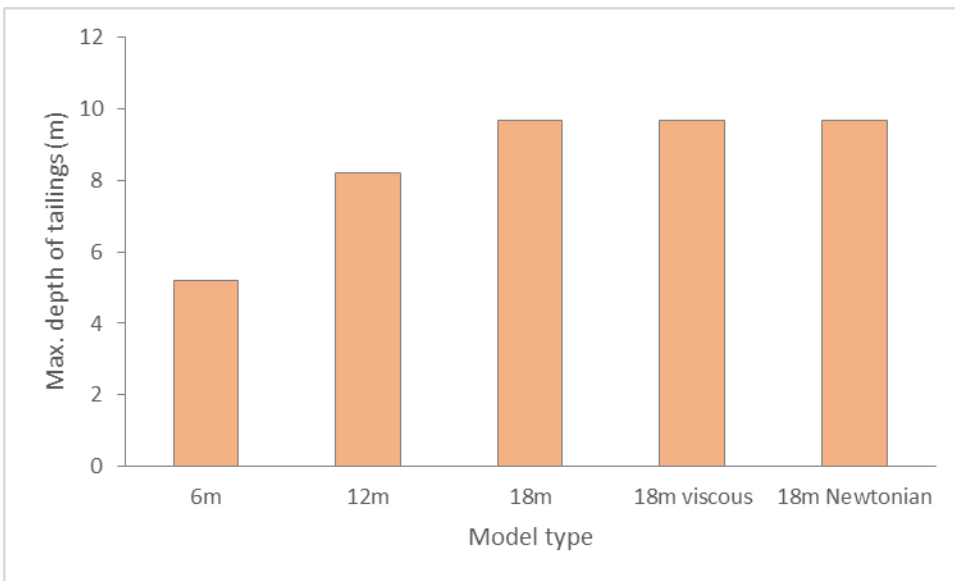
Fig. A8. Variation in maximum depth of tailings for a breach of the eastern end of the north side of the eastern tailings basin cell. Modeling used breach, rheological, and landscape roughness characteristics from Tables A1-3 unless indicated otherwise (model names include breach depth; viscous = maximum values from Table A1; Newtonian = Newtonian not Bingham fluid).
